# Portage Creek Sediment Remediation Project Kalamazoo, Michigan

Pre-Sediment Removal Structure Feature Assessment  
Removal Areas SA3-A, SA3-B and SA3-Access

F&V Project Number: 809930

August, 2012

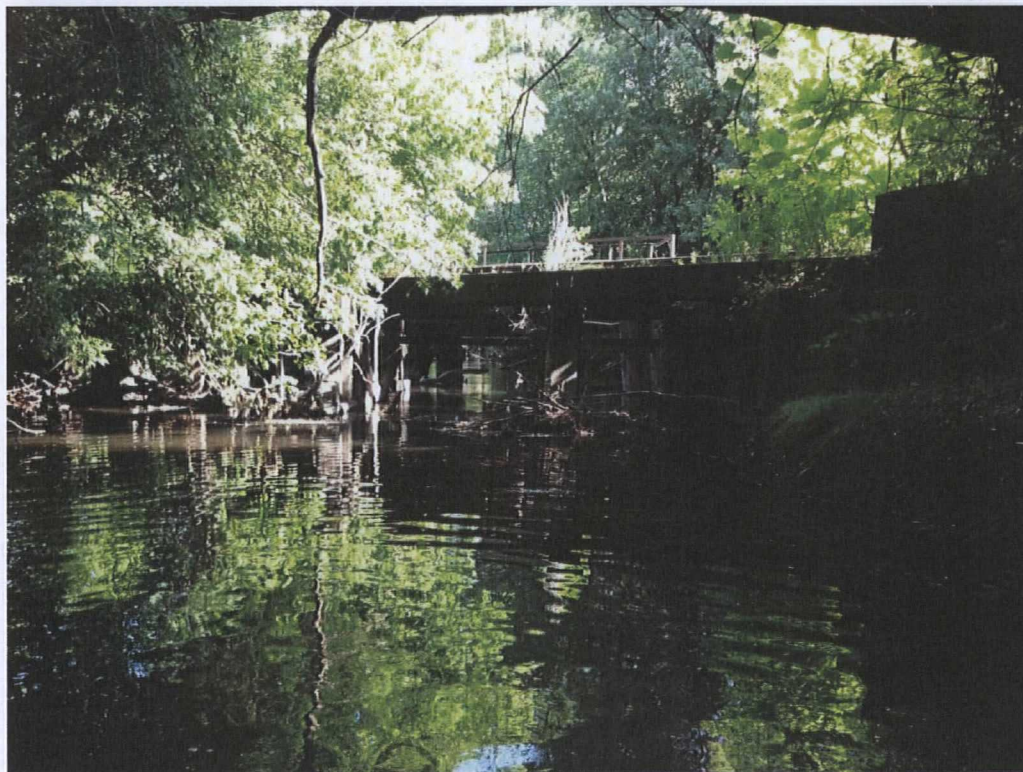
Elevation view of the structure

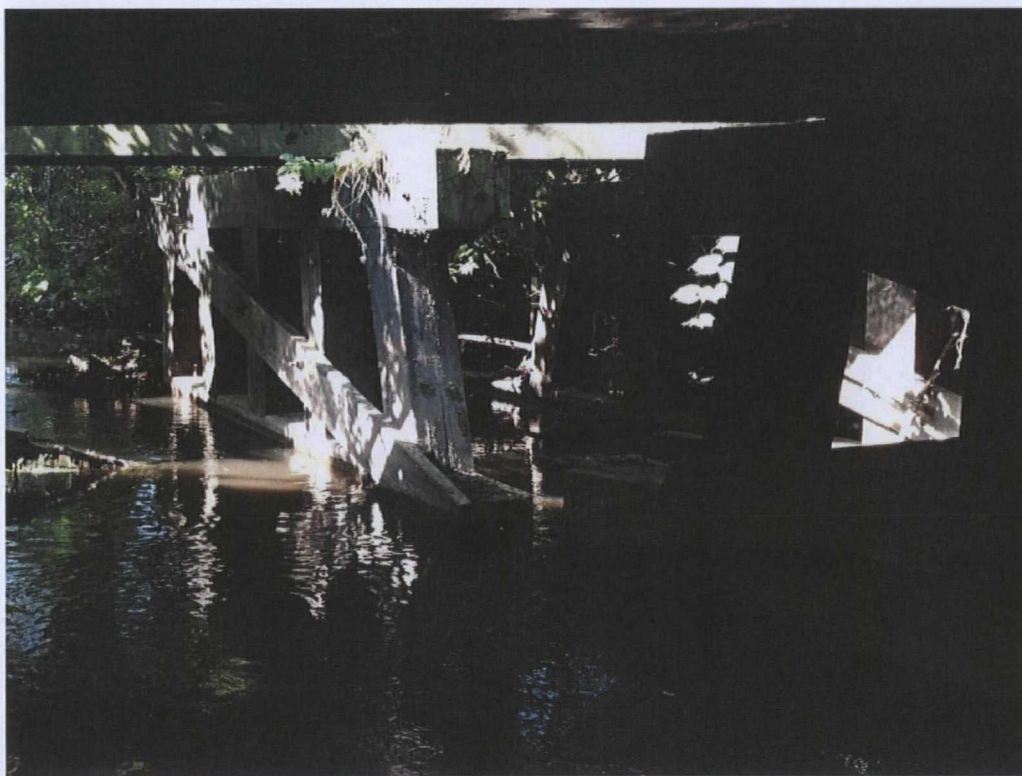
Vegetation growth on timber bent

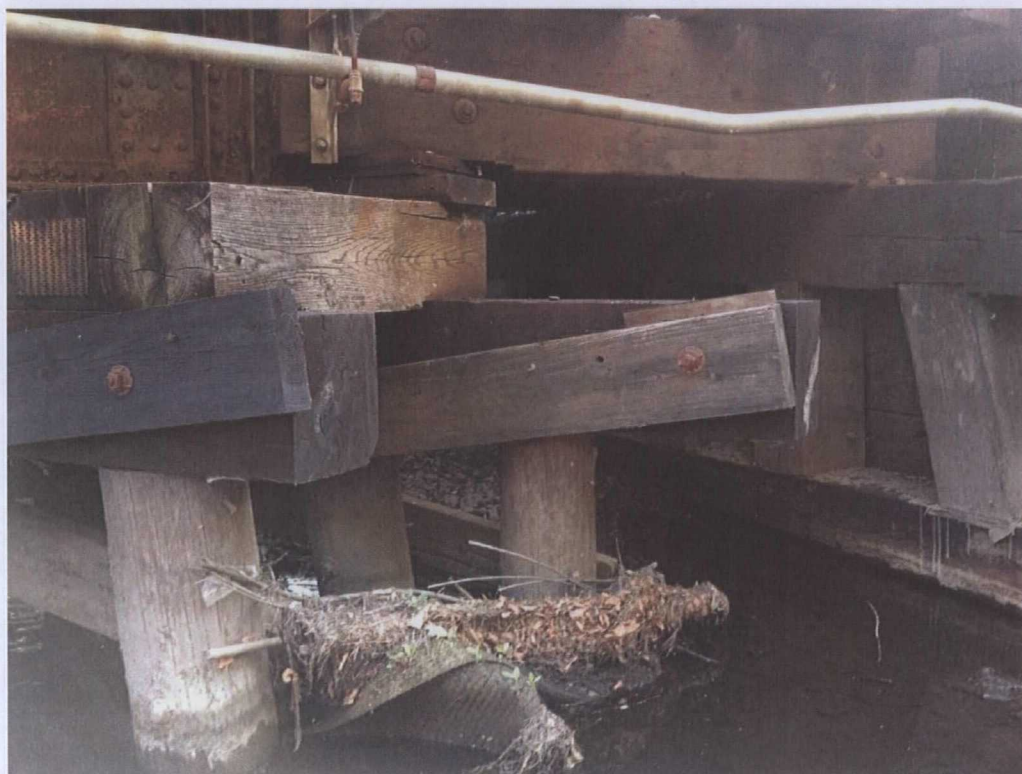
Debris on upstream end of structure

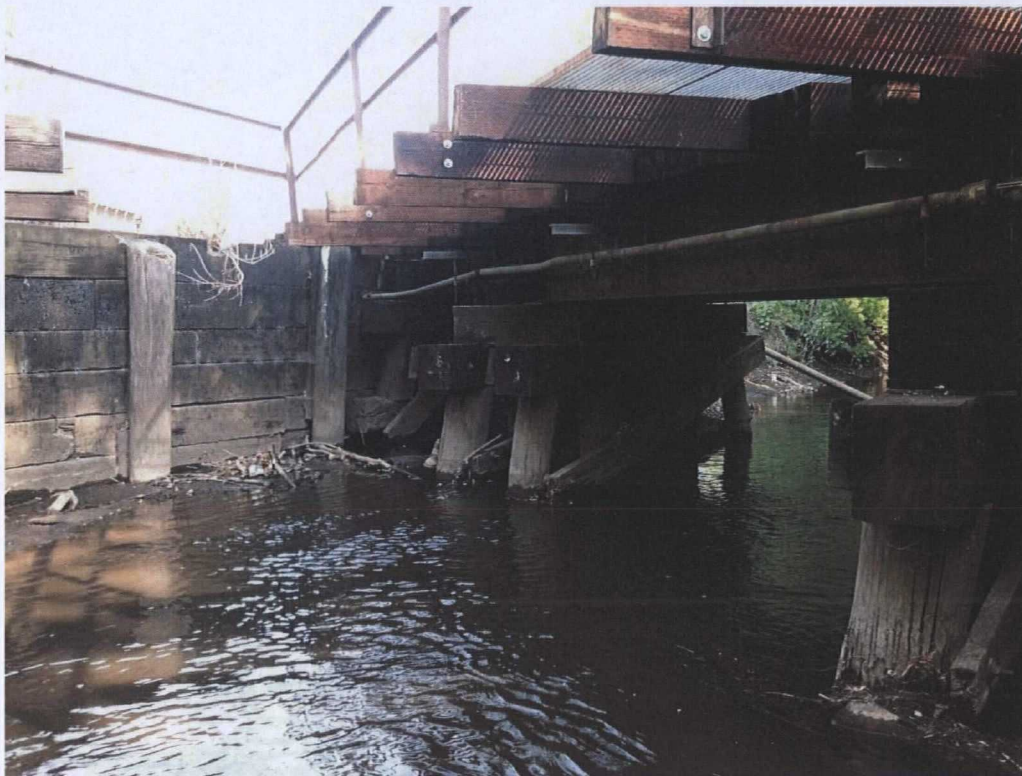
Conduit supported on south side of north structure

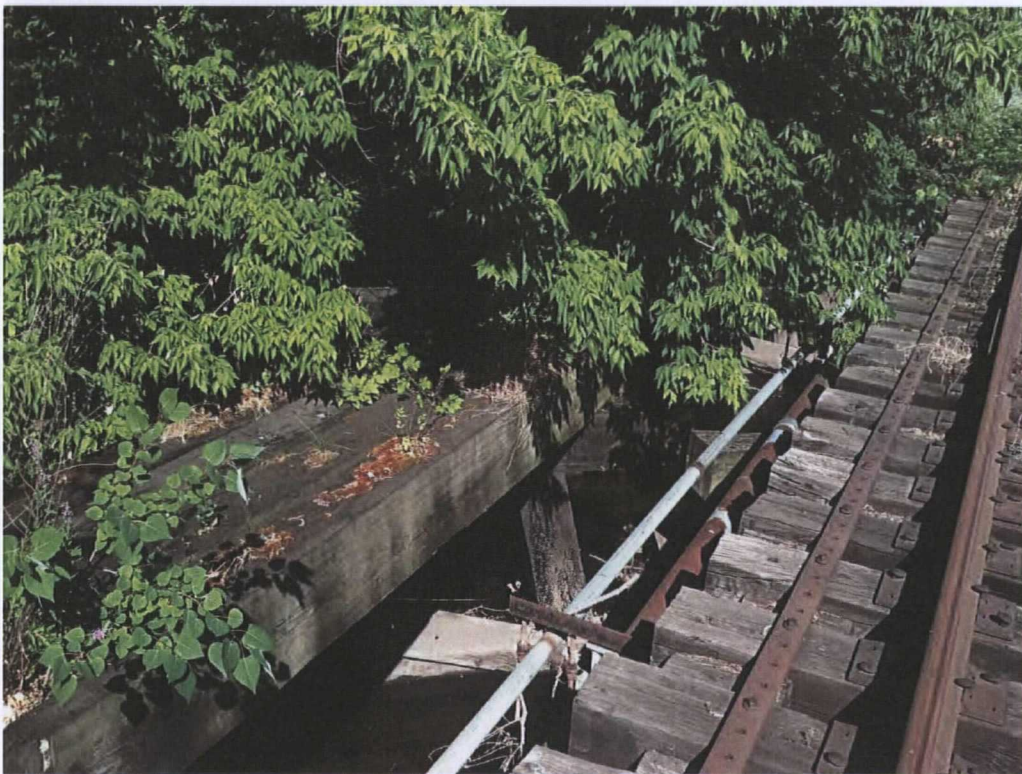
Tree and brush growth encroaching on structure

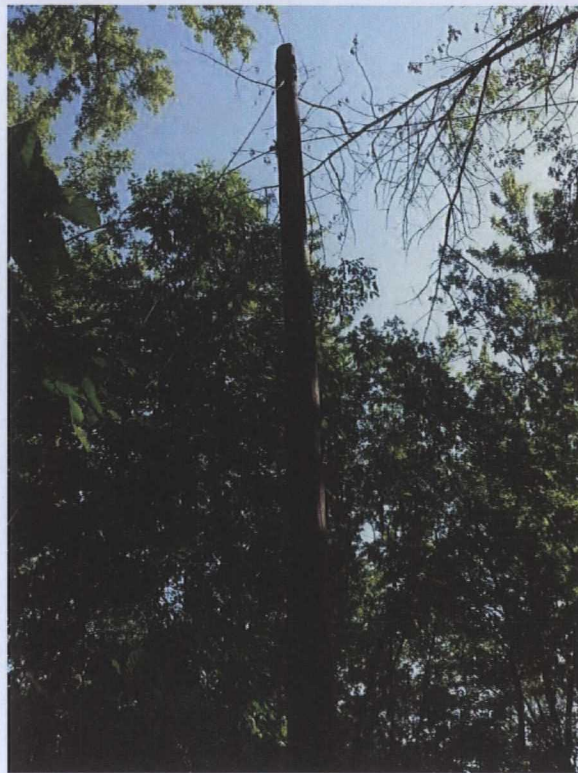
View of the overhead facilities carried by the pole

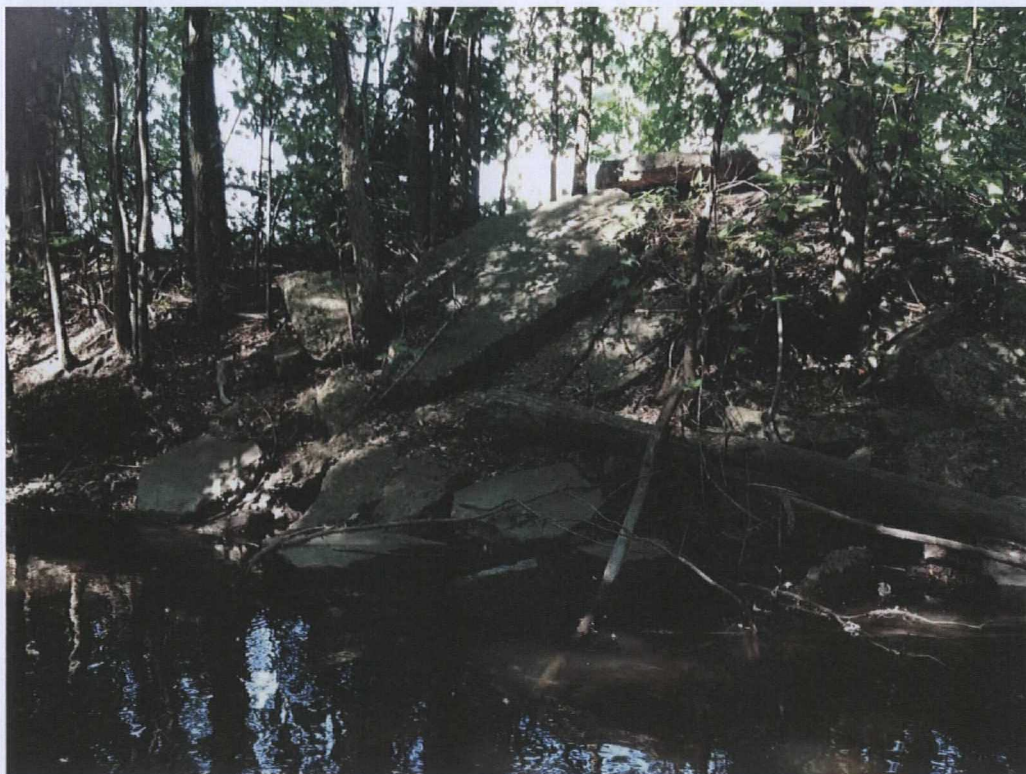
View of the structure from the channel

- The slabs should be removed and replaced as required to facilitate sediment removal.

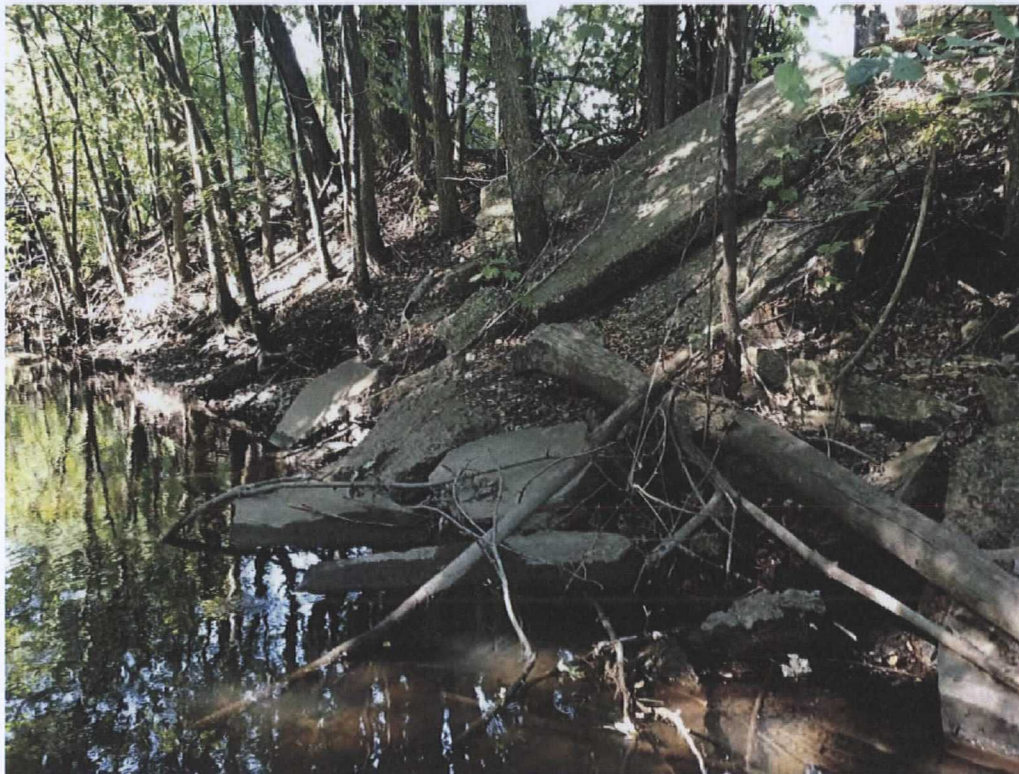
View of the structure from the north channel

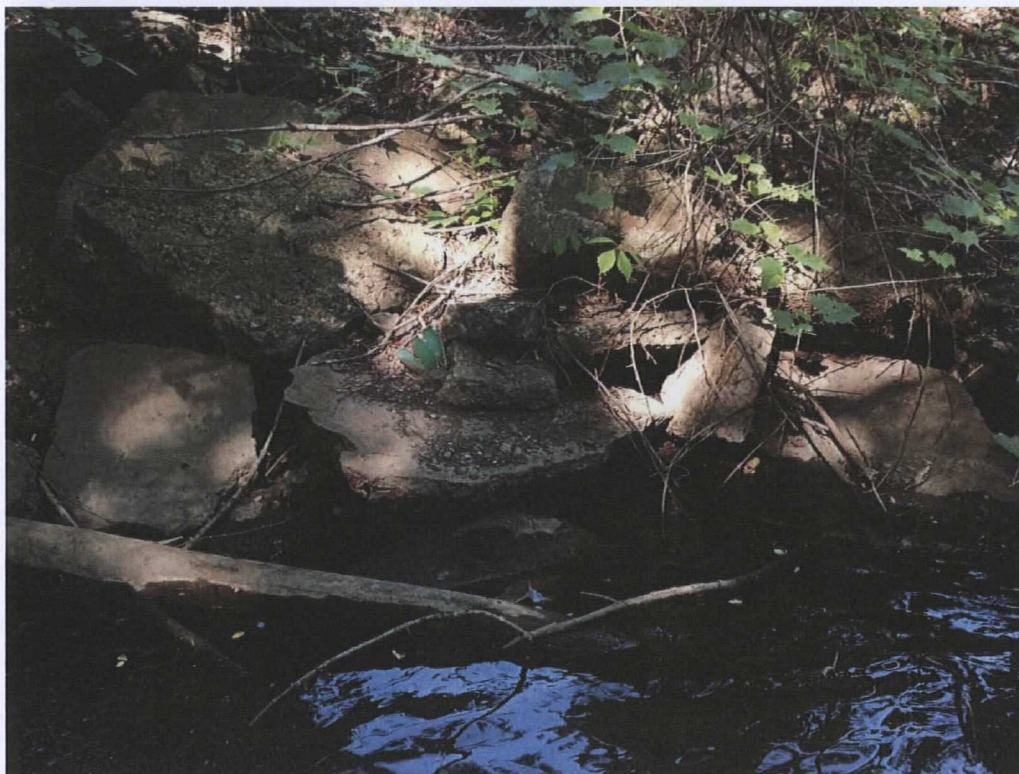
Settlement of slabs into the channel

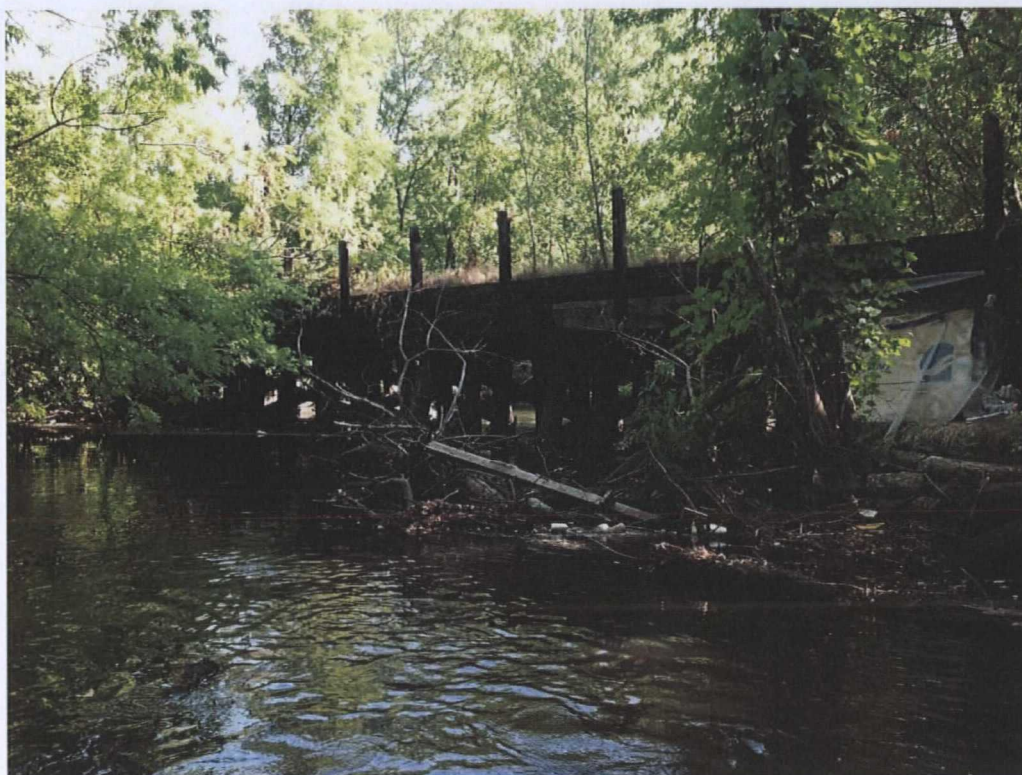
View of the structure from the south channel

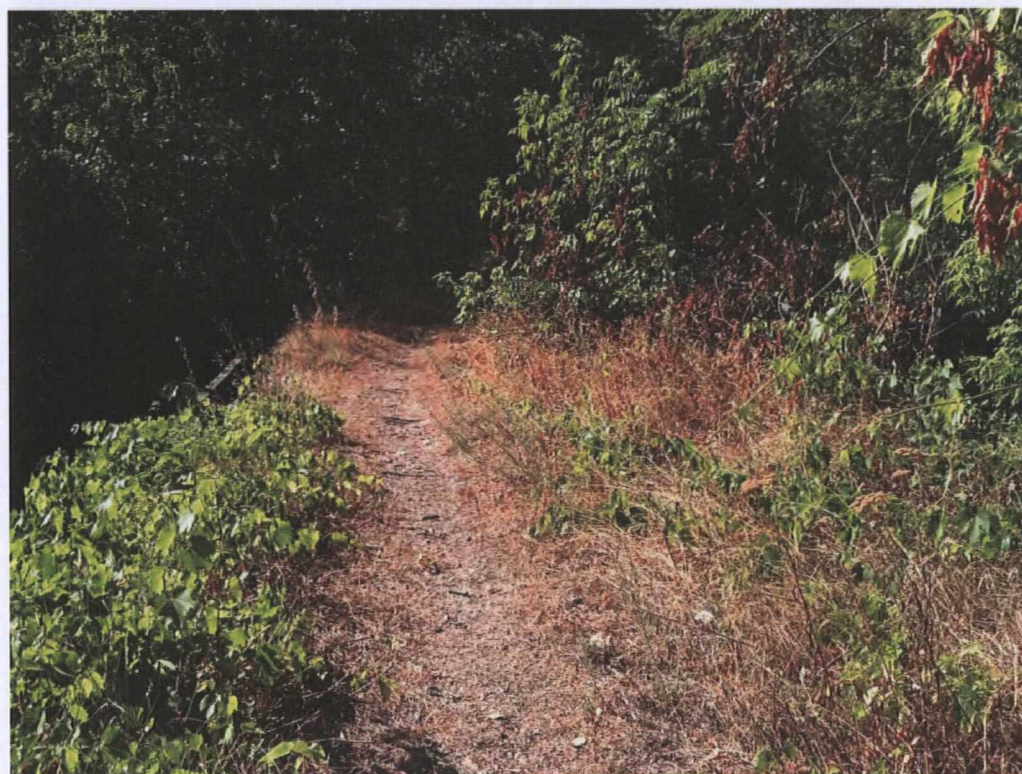
Heavy surface debris and vegetation

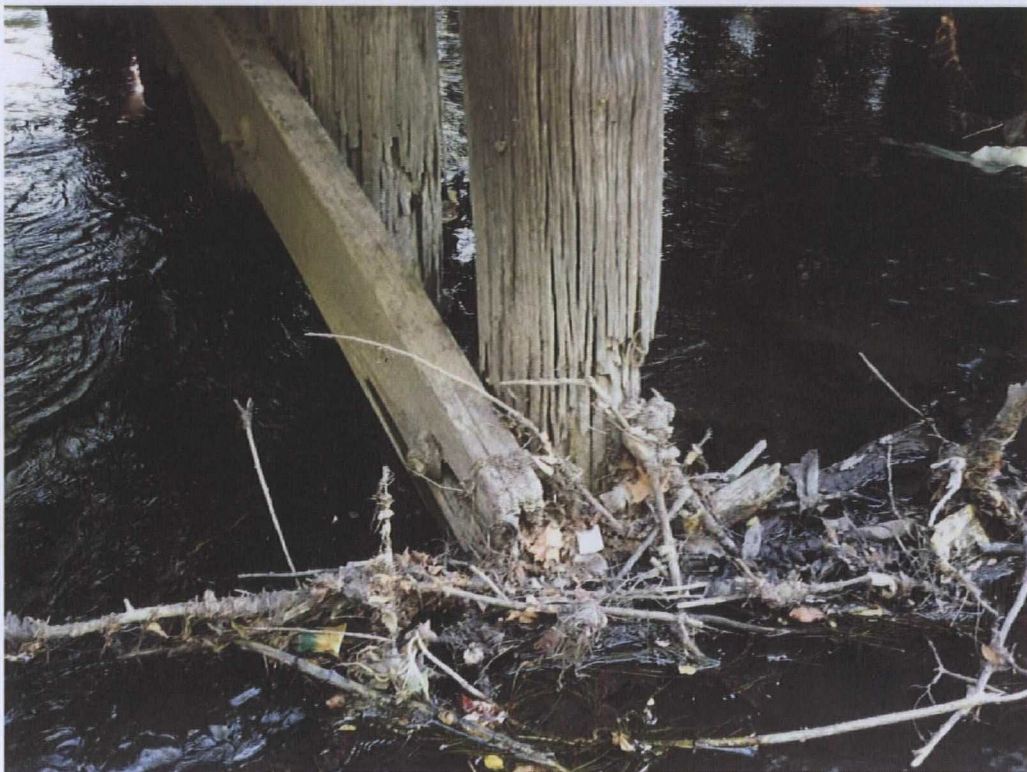
Severe section loss on timber pile

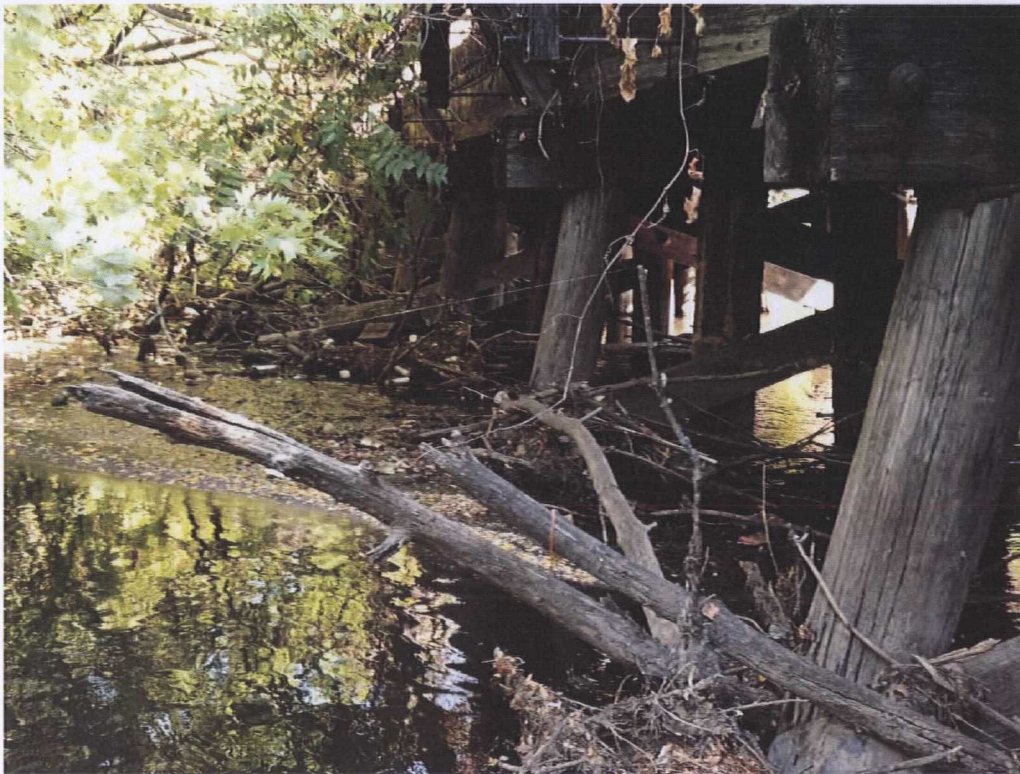
Woody channel debris on upstream end of structure

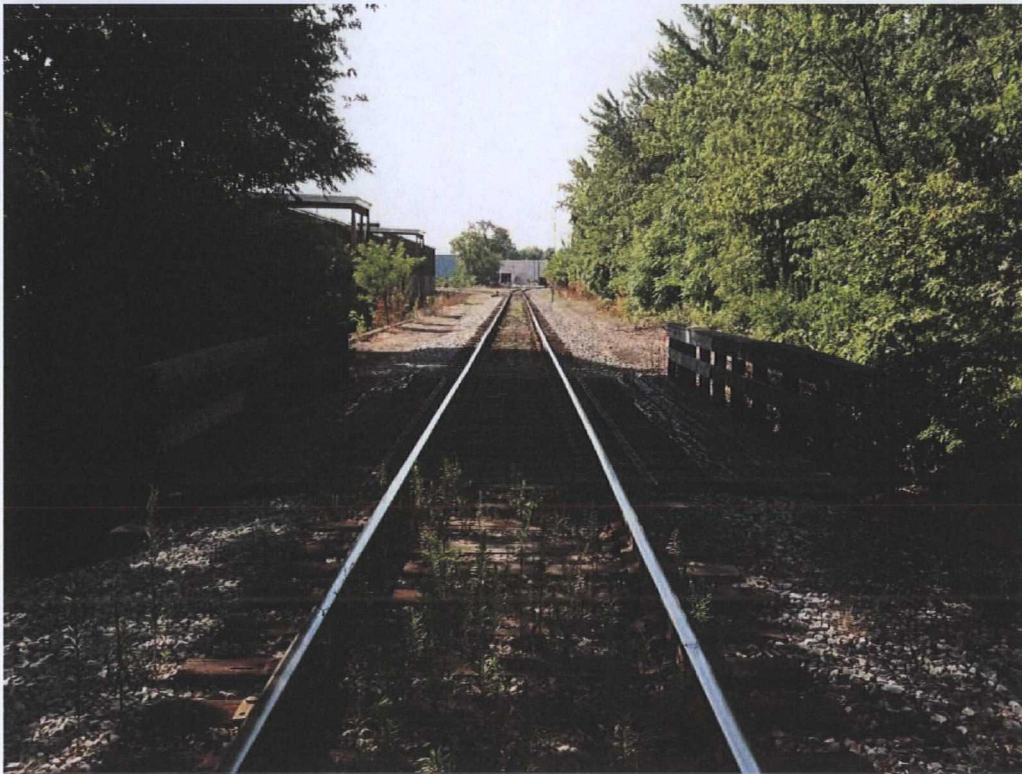
View of structure from approach track

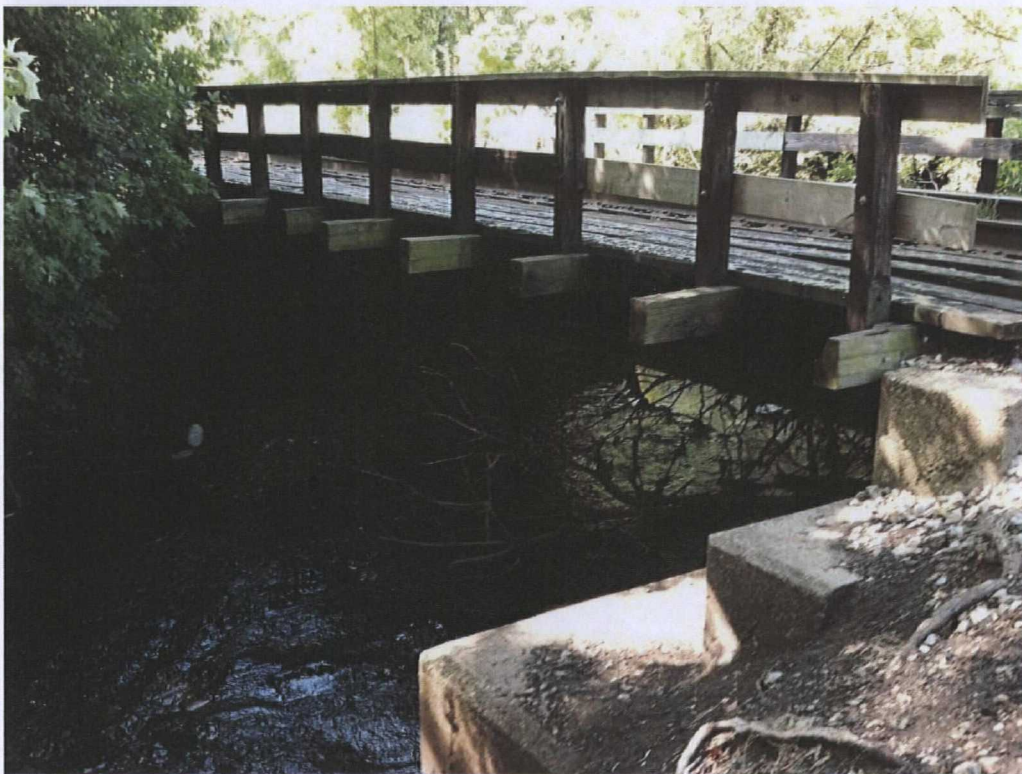
Elevation view of structure

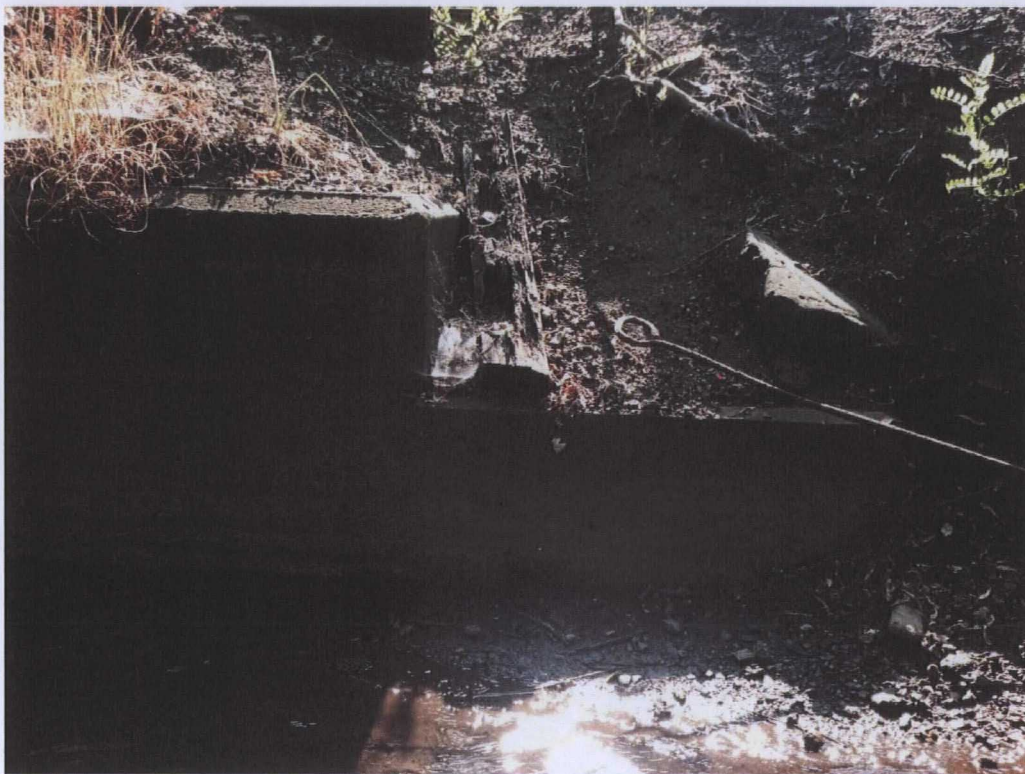
Severe bank erosion at abutment

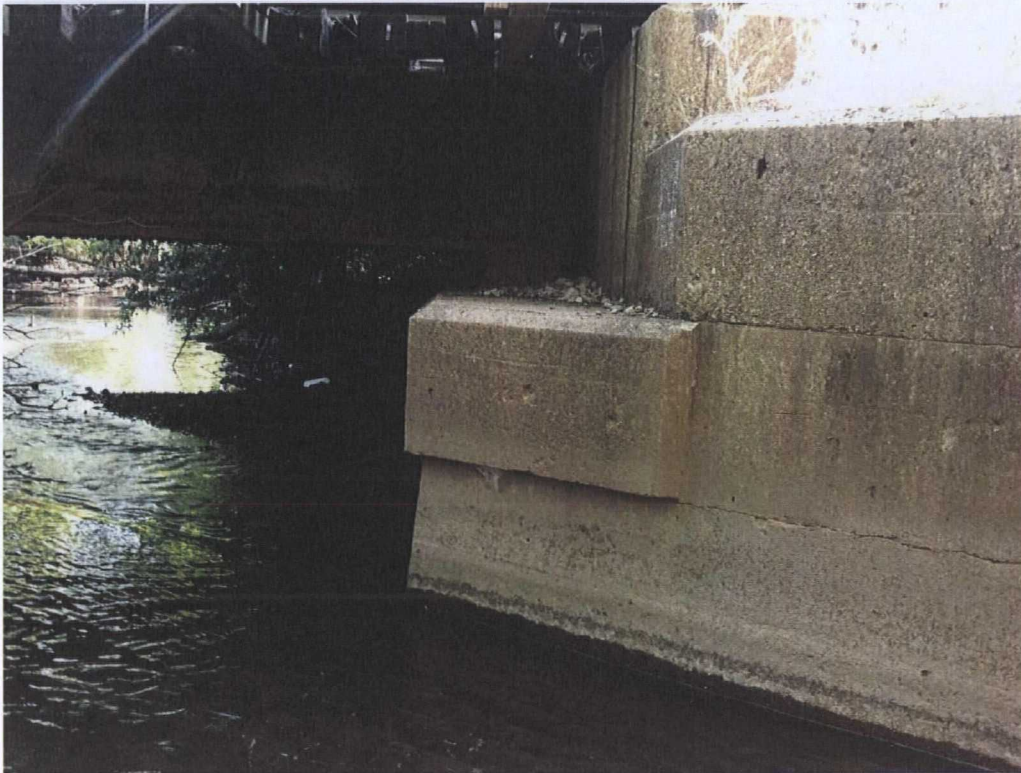
View of bearing area with debris on bridge seat

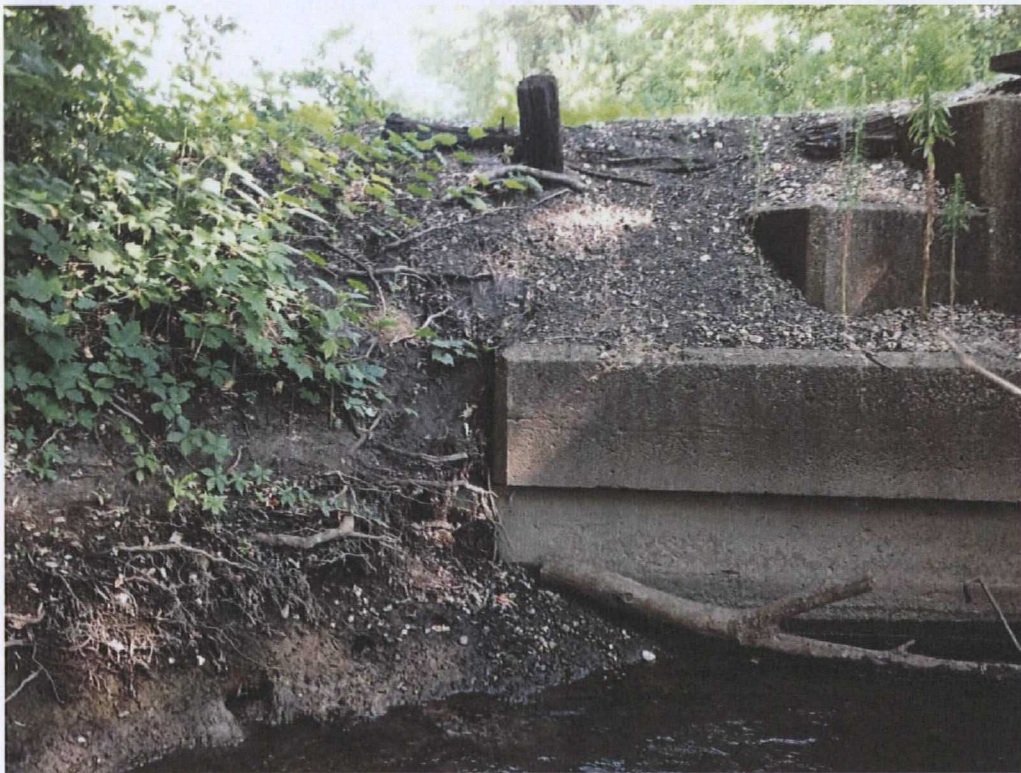
Severe bank erosion along abutment

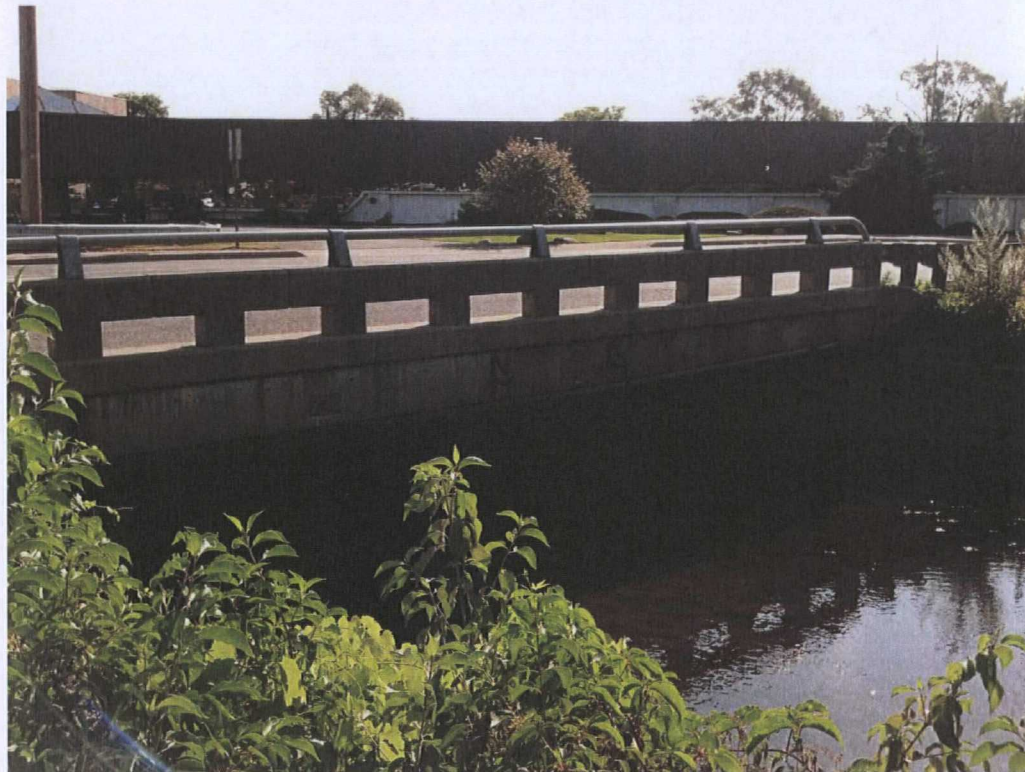
Elevation view of structure

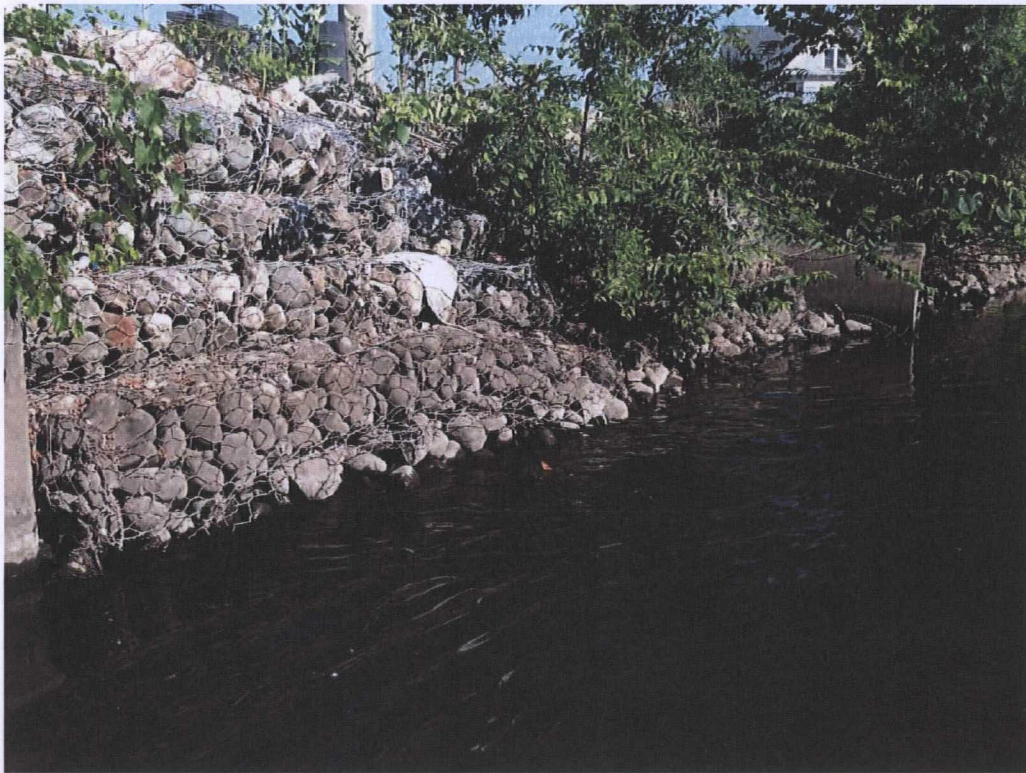
Gabion baskets in northwest with brush growth and displaced stones at waterline

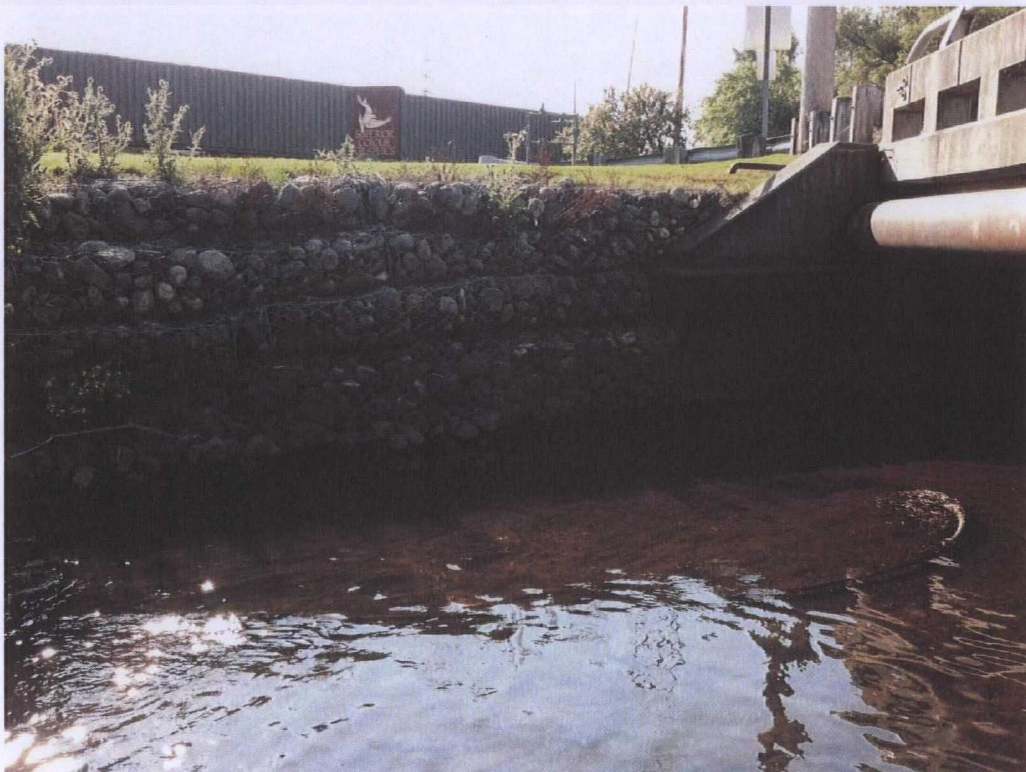
Gabion baskets in northeast with brush growth and displaced stones at waterline

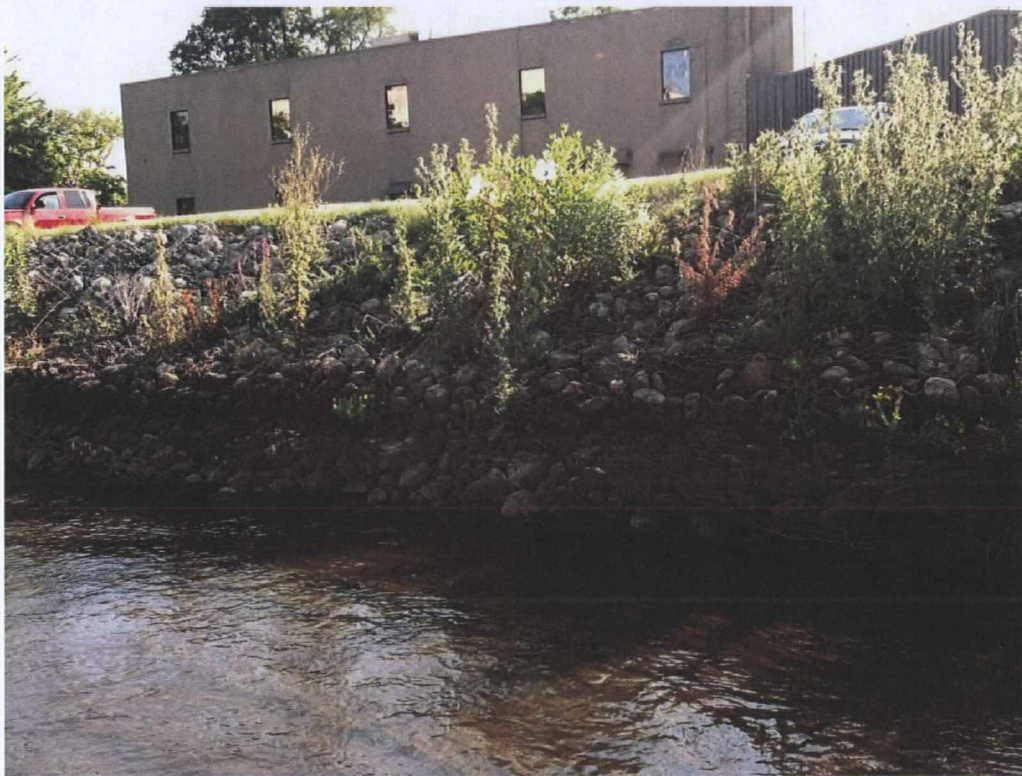
Gabion baskets in northeast with brush growth and displaced stones at waterline

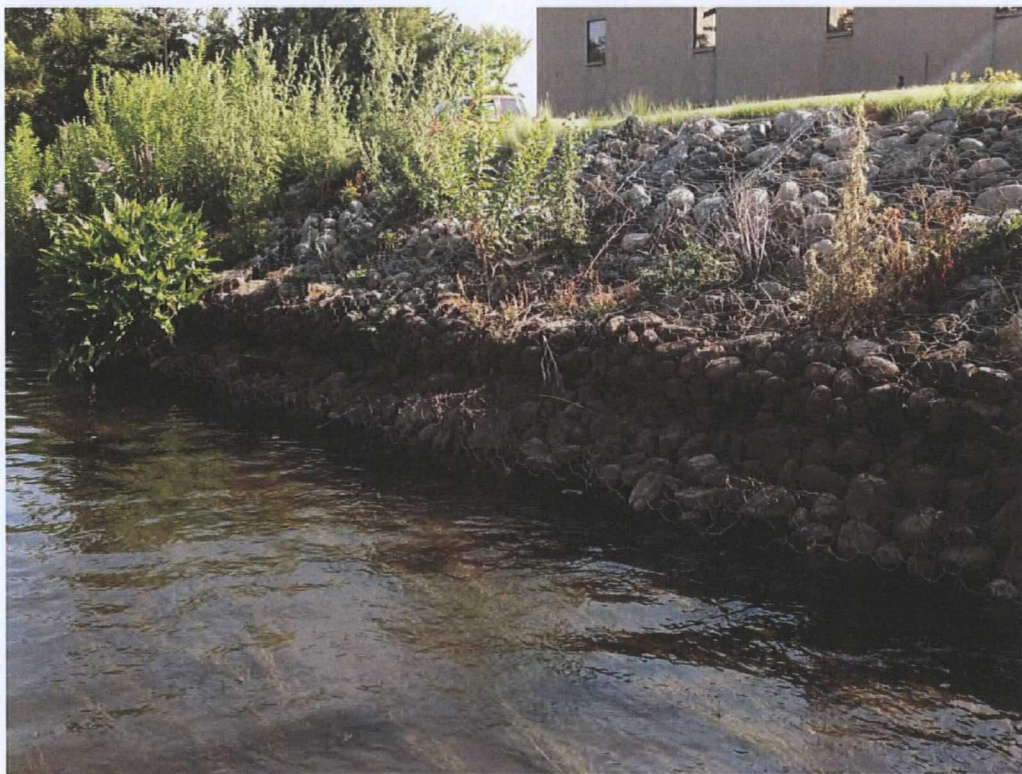
Gabion baskets in northeast with brush growth and displaced stones at waterline

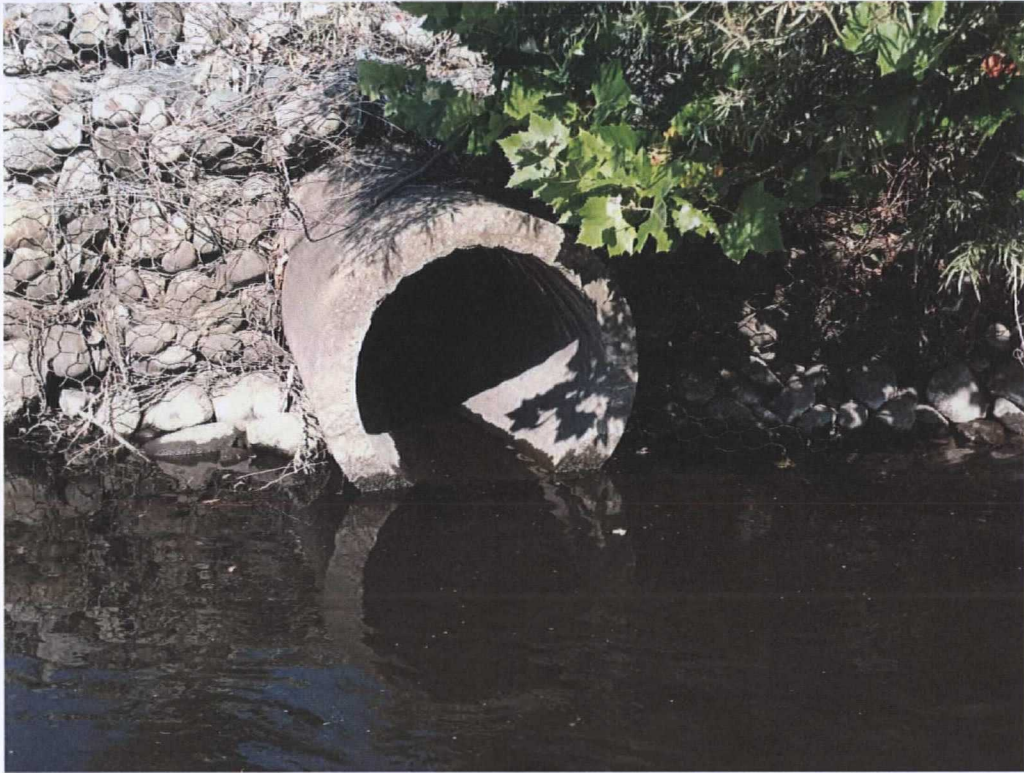
- Approximately 3' of the pipe is exposed beyond the face of the gabion baskets.
- There is a plunge pool approximately 2' deep around the outlet.
- The concrete pipe is in fair to good condition.

Outlet viewed from the channel

- If a cofferdam is required for dewatering, it should be installed with a minimum 2' clearance to the outlet to avoid adversely impacting it. It will be difficult to install a sheet pile cofferdam against the gabion baskets without damaging them. Therefore sand bags are recommended either against the baskets or for the entire cofferdam.

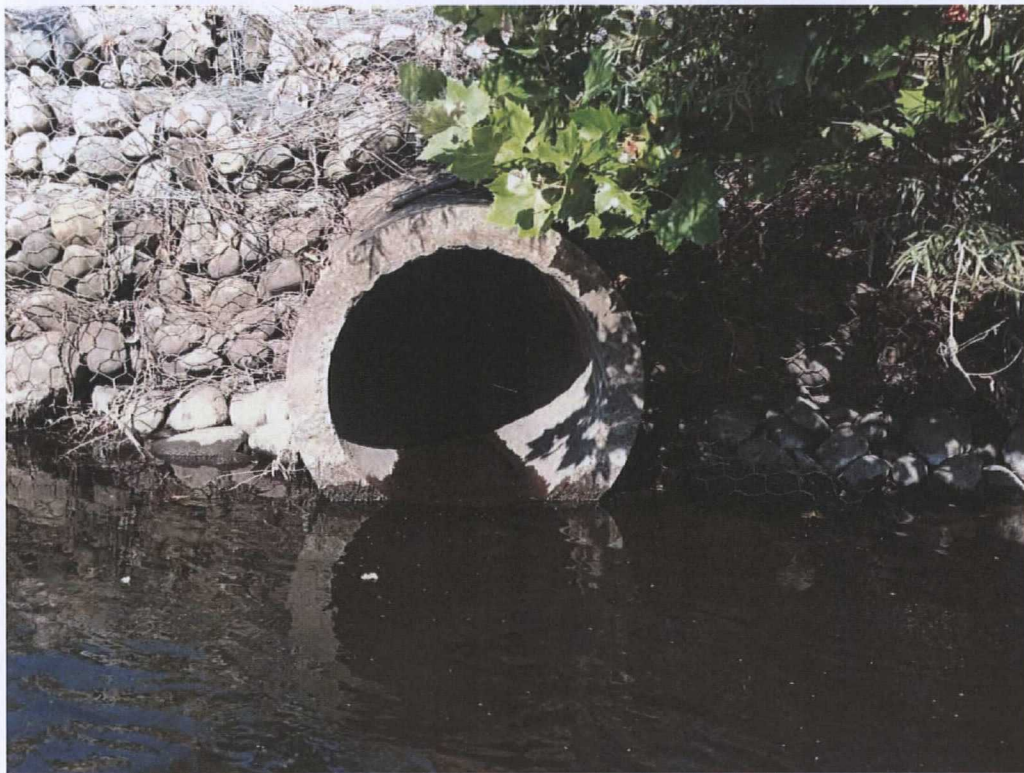
Stone loss in baskets along the waterline

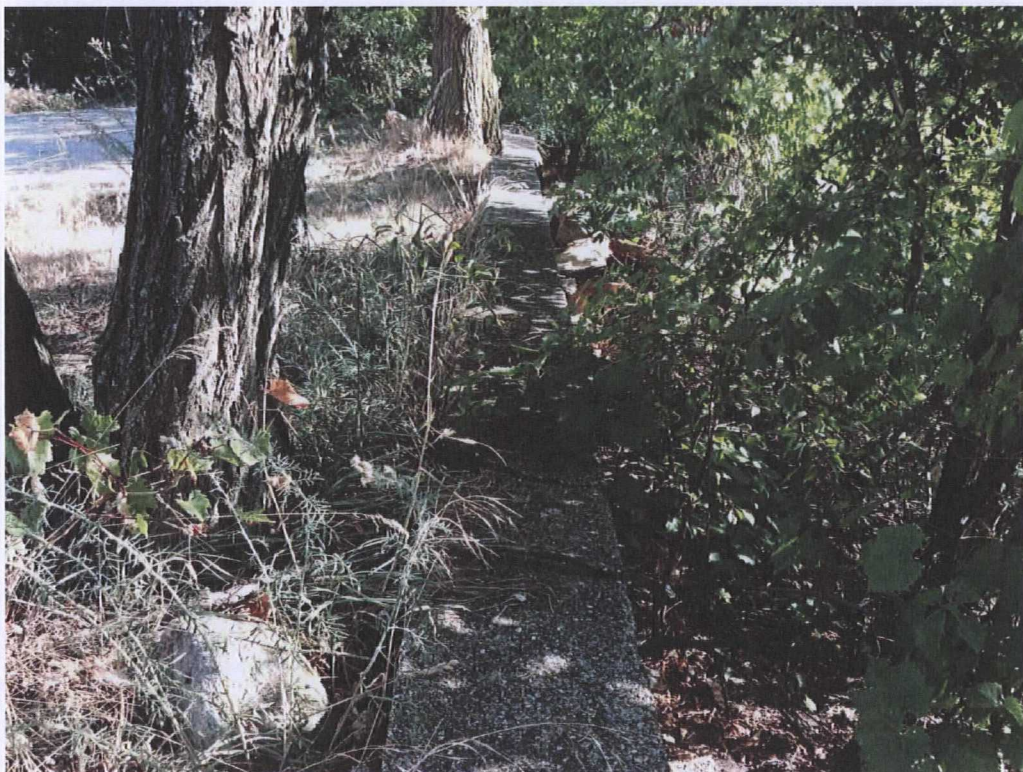
- The concrete retaining wall is in poor condition, leaning in several locations. There are several severe to critical vertical cracks in the wall. Growth of a large tree behind the wall has caused ~2" offset at one of the cracks.
- The parking lot is newer concrete paving.

View of the retaining wall from the south

- The wall and lot are far enough removed from the channel to avoid impact, however they should be protected from equipment damage during the work.

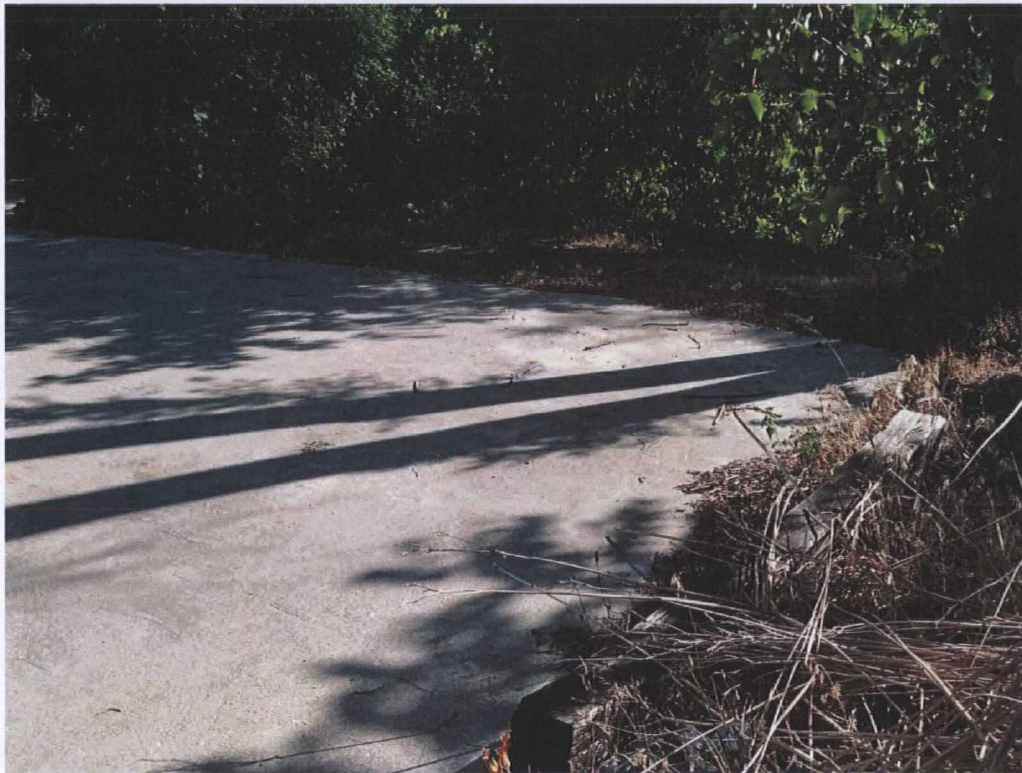
View of parking lot along top of bank

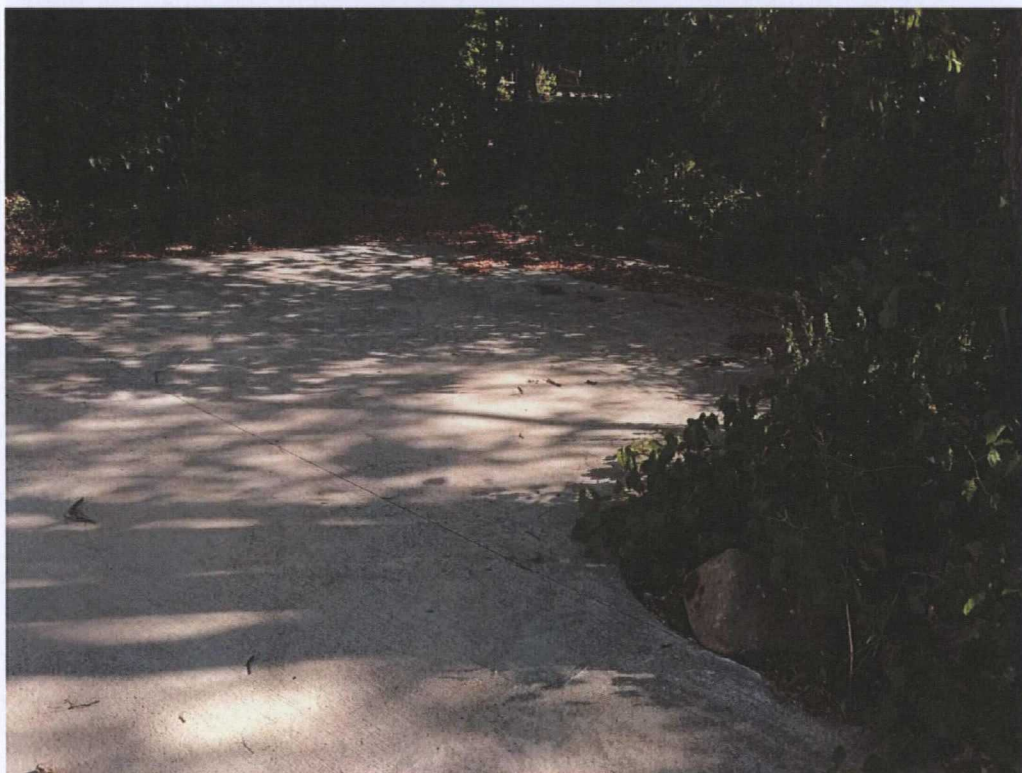
View of parking lot along top of bank

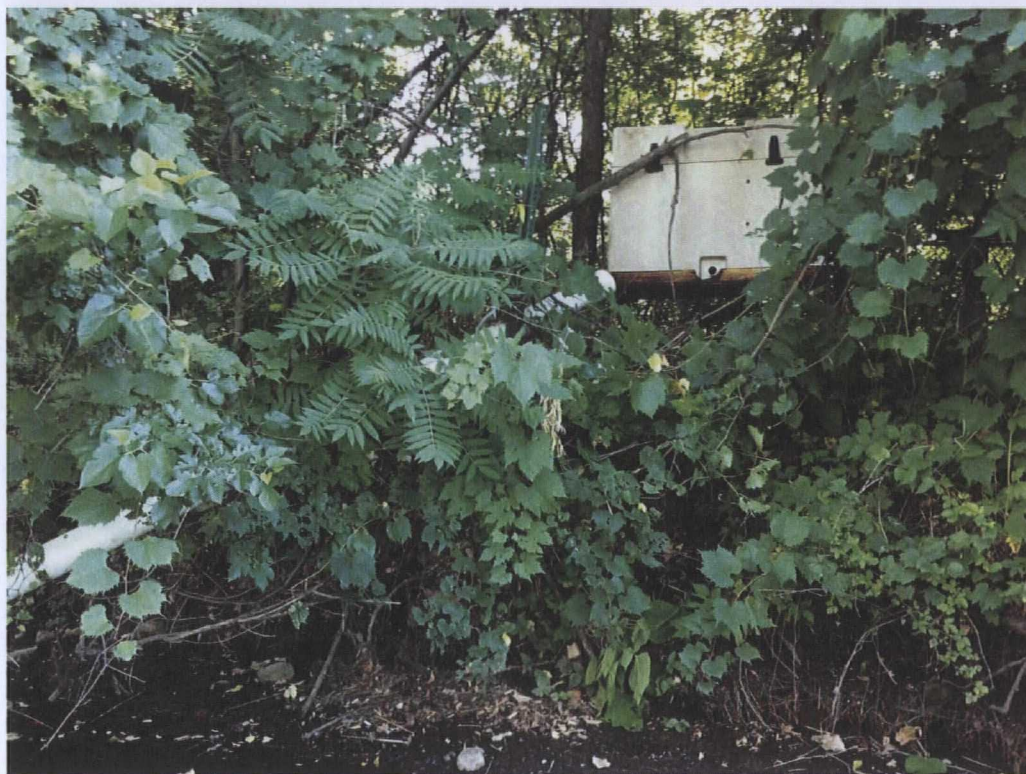
- There is moderate corrosion on the steel post in the channel.
- The PVC sampling tube is not connected to the unit at the top of the bank.

View of structure from channel
